## Strength-deformation analysis of wheel reducer for metro cars

Wheel reducer, Metro cars, Strength-strain analysis, Finite element method, Operational reliability, EZK-MEM coupling.

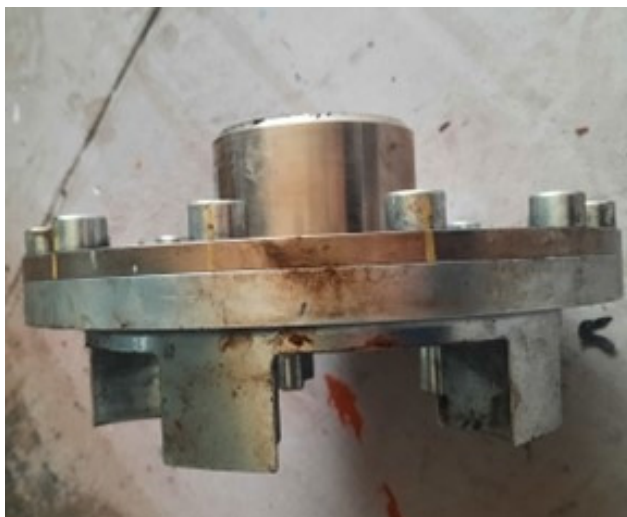
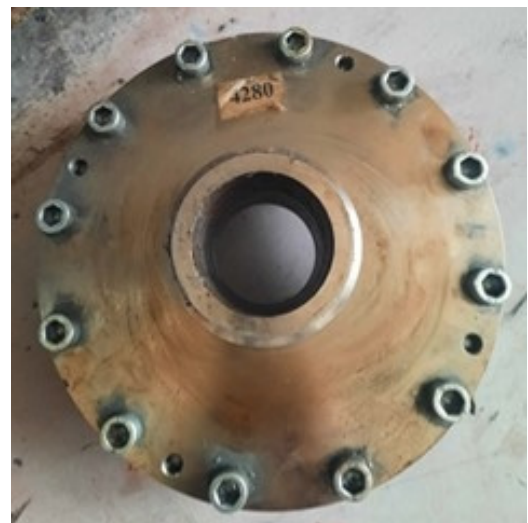
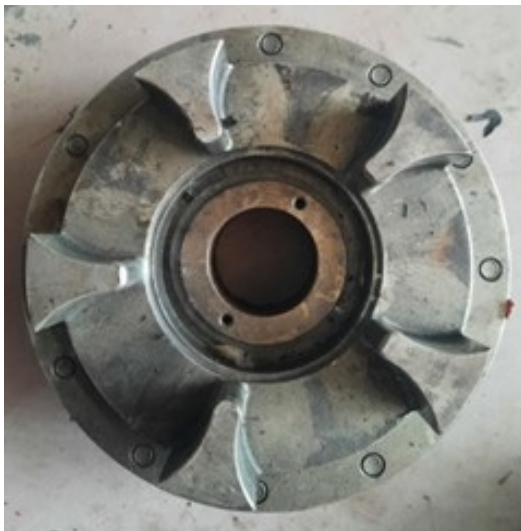
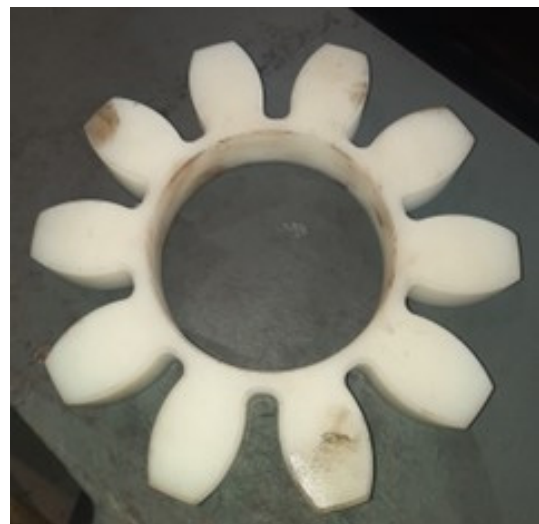
The clutch consists of two half-clutches and an elastic gear ring. The half-clutches have the same design, each of them consists of a hub 2, a gear housing 3. The torque is transmitted from the traction motor through hub 2, the gear housing 3, the elastic ring 1 and the shaft of the small gear wheel of the reducer (Fig. 5÷10).

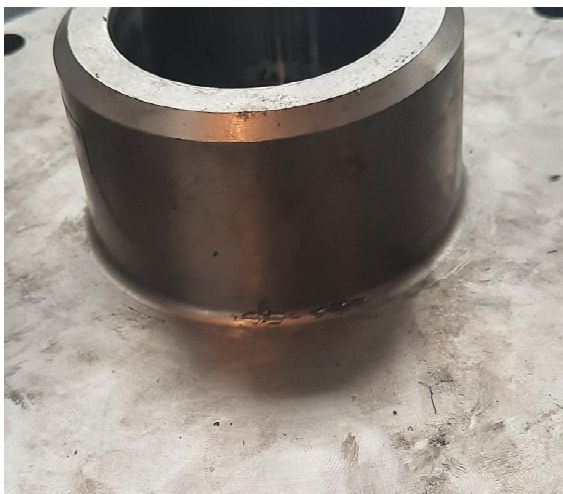
Figure 11:

According to the conducted statistical study and observations of the studied unit, it was found that the most common damages to the elastic membrane coupling are rupture of the housing of one coupling part (Fig. 11), presence of cracks on the housing part (Fig. 12) and twisting of the coupling part (Fig. 13).

After conducting observations and analyzing the operational condition of the unit under consideration, it was found that the main cause of damage to the elastic membrane coupling is the coupling installation method. This is most likely due to the practice in the depot of lowering the traction motor with a crane. This method leads to inaccuracy and imprecision, as the positions of the shaft, gearbox and motor are not within the tolerances for each installation. When installing with unacceptable tolerances, misalignment occurs, with one half pressing the other, which during operation causes breakage or cracks to appear on the housing of one half. When installing the half coupling with the shaft, good contact must be obtained between the coupling hub and the traction motor shaft or the gearbox shaft. If the required contact spot is not achieved, the fitting (rubbing) is carried out with grinding paste. Clutch slippage is due to a contact spot with an area of less than 75% and poor fit (grinding) with the grinding paste on one clutch half.

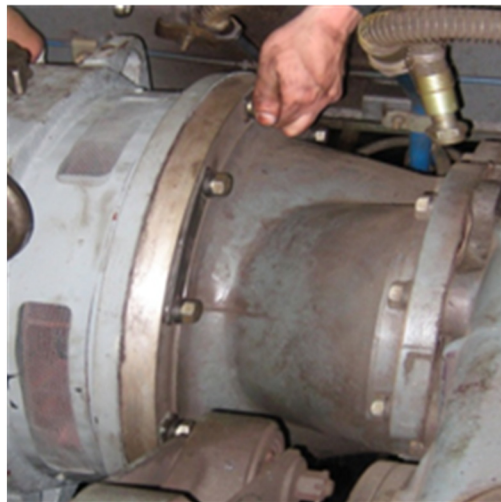
Figure 14:

The suspension of the traction motor and the reducer is a support arm with transmission of torque to the axles through a hollow shaft with articulated guides with sleeves. The TED is fastened to the reducer by a transition flange around the small gear (Fig. 14). The flange is fastened to the TED and the reducer with bolts.

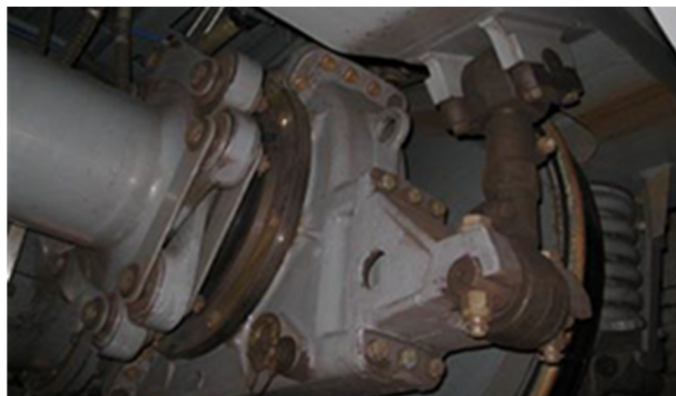
Figure 15:

In the lower part of the transition flange there is an opening connected by a tube to the lower part of the reducer. This helps to return excess oil from the housing of the compensation sleeve to the reducer. The suspension of the reducer has a similar bracket in its rear part on the side of the small gear; it is attached with the universal bracket with a suspension to the central cross member of the bogie frame. On the side of the output shaft of the reducer to its housing there is a bracket mounted by bolts. The bracket with the help of two bolts passing through it, nuts and lock nuts is connected to the metal-rubber joint of the universal bracket. The metal-rubber joint in its upper part has a thread on which an adjustment sleeve is screwed (Fig. 15).
