## Tests for the assessment of devices for securing semi-trailers during transport on a freight wagon

Dragan Milković<sup>1\*</sup>, Saša Radulović<sup>2</sup>, Aleksandra Kostić Miličić<sup>1</sup>, Goran Simić<sup>2</sup>, Ognjen Obradović<sup>2</sup>

<sup>1</sup> University of Belgrade, Faculty of Mechanical Engineering, Rail Vehicle Department, Belgrade, Serbia

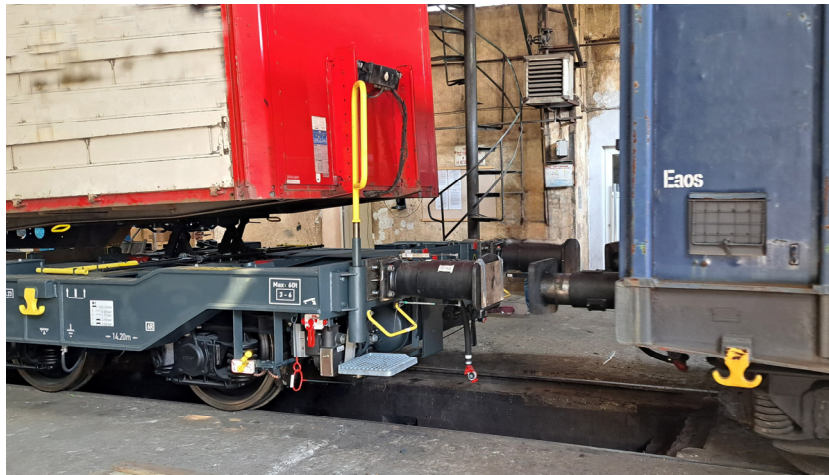
Figure 2: Buffing impact test [8]

In accordance with structural strength requirements for freight wagons, buffing impact tests shall be conducted using a fully loaded configuration with a semi-trailer weighing 40 tons. Given that the vehicle belongs to the F-II category for combined transport, it is specifically designed for careful shunting operations. Consequently, the baseline certification tests were performed at impact speeds up to 7 km/h. As the partner (impact) wagon was used Eaos wagon loaded to a total mass of 80 tons (Figure 2). During these baseline trials, no structural damage or permanent deformations were observed on either the wagon frame or the trailer hitch mechanism. The peak longitudinal accelerations recorded on both the wagon and the semi-trailer chassis stabilized at approximately 1g.

Within the scope of research regarding the development of sacrificial crash elements [8], further experimental trials were carried out at higher impact velocities to evaluate cargo protection under improper shunting conditions. The integrated crash elements within the trailer hitch are designed to deform plastically and dissipate kinetic energy when shunting speeds exceed 7 km/h, thereby capping the acceleration transmitted to the cargo at a maximum threshold of 2g. To determine the ultimate structural margins of the coupling, extreme testing scenarios were conducted using compromised or rigid elements. Under these severe conditions, the longitudinal interface between the trailer hitch and the wagon was subjected to extreme accelerations reaching up to 3g. Despite these highly elevated dynamic loads and the resulting severe pitching moments, the structural integrity of the connection was maintained, and no unlocking or slippage of the kingpin from the trailer hitch occurred, demonstrating compliance with the safety margins [5].

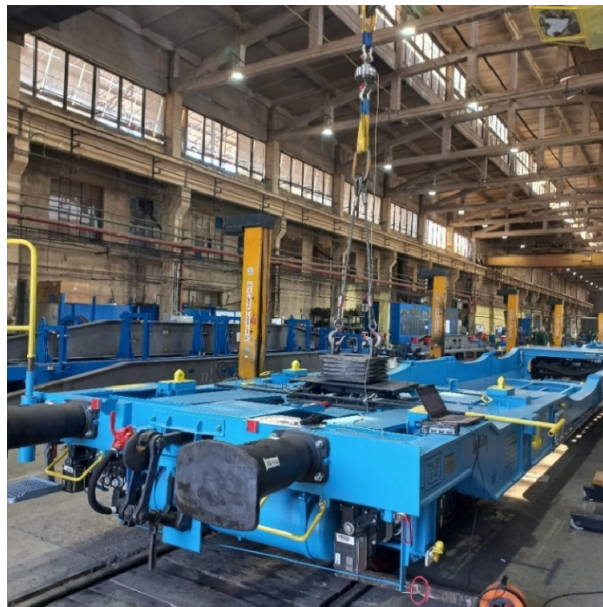
Figure 3: Tensile upward force [9]

The validation test on the Sdggmrss wagon involved applying a vertical tensile load of 85 kN to a secured, ECE Regulation 55-compliant H50-type kingpin, with load monitoring and testing continuing until the wagon lifted from the rails [7]. The procedure, conducted with the securing device in the mandated position, verified that the locking capacity exceeds the required minimum [1, 7].

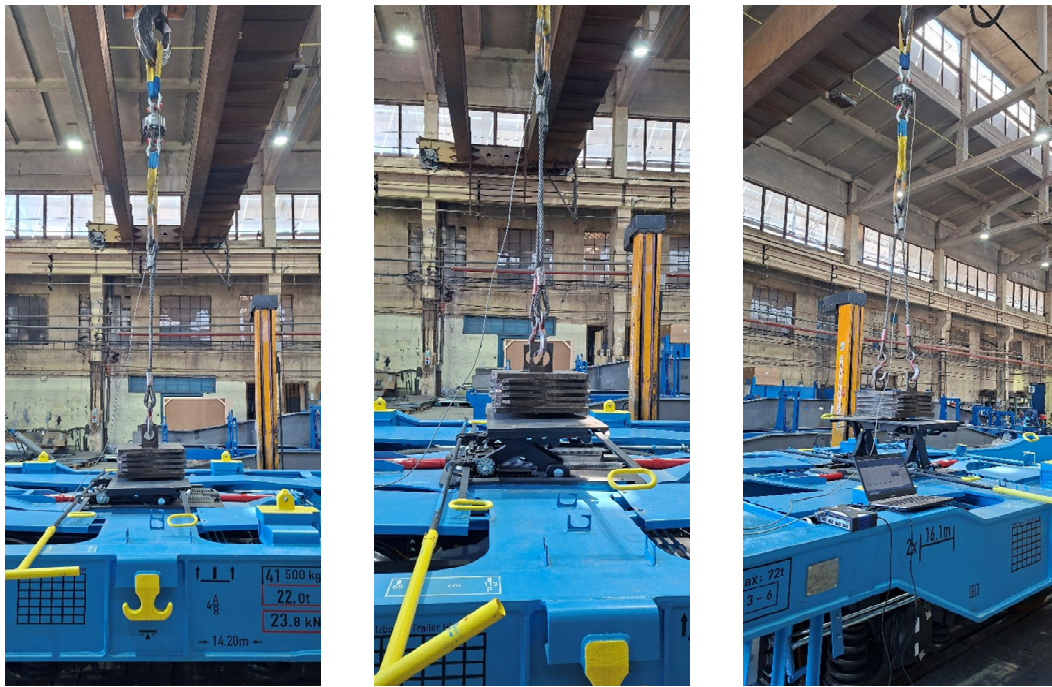
Figure 4: Hitch positions during testing (880, 980, 1130 mm) [9]

To ensure measurement accuracy, the dead weight of the test adapter was excluded from the tensile force data by taring the load cell system while the adapter was suspended but not yet locked [9]. The experimental procedures were conducted at the specific operational positions designated for the securing device. Prior to and following each test cycle, a thorough visual inspection of the locking mechanism, locking pin, and securing device was performed to verify proper functionality and ensure the absence of visible damage or permanent deformation. To guarantee reproducibility, the test was repeated three times for each designated configuration. Vertical tensile load tests were systematically executed at three distinct securing device heights: 880 mm, 980 mm, and 1130 mm (Figure 4).

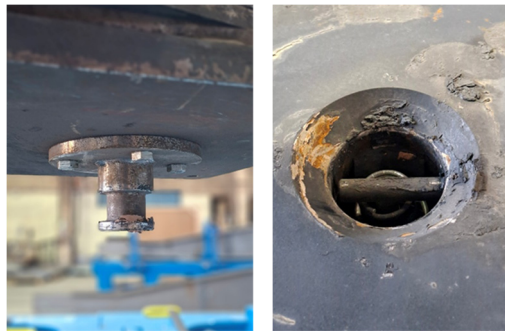
Figure 8: Kingpin and locking mechanism after testing –no visible damage [9]

Figure 8 illustrates the post-test condition of the kingpin and locking mechanism, confirming the preservation of structural integrity with no visible damage or permanent deformation. Inspection revealed only minor, superficial paint degradation, indicating that the component's functionality was not compromised.
