# Impact of deteriorated tram tracks on the current collectors of trams

This article presents the results of a measurement campaign conducted during the summer of 2025 in Sofia. The study aims to determine the impact of deteriorated tram tracks on the current collectors of trams. Measurements were carried out on sections of the tram network where the tracks are in emergency or pre-emergency condition. The measured parameters include linear accelerations, angular velocities, and magnetic field values along the three axes. The sensors were positioned on the tram roof and on the collector strip holder. The analysis of the findings includes a comparison of the parameter values recorded at both locations, a general assessment of their impact on the current collector, and a comparison with results from a previous study conducted in 2019. Based on the obtained data, conclusions have been drawn regarding the influence of the tram's lateral sway on the current collector.

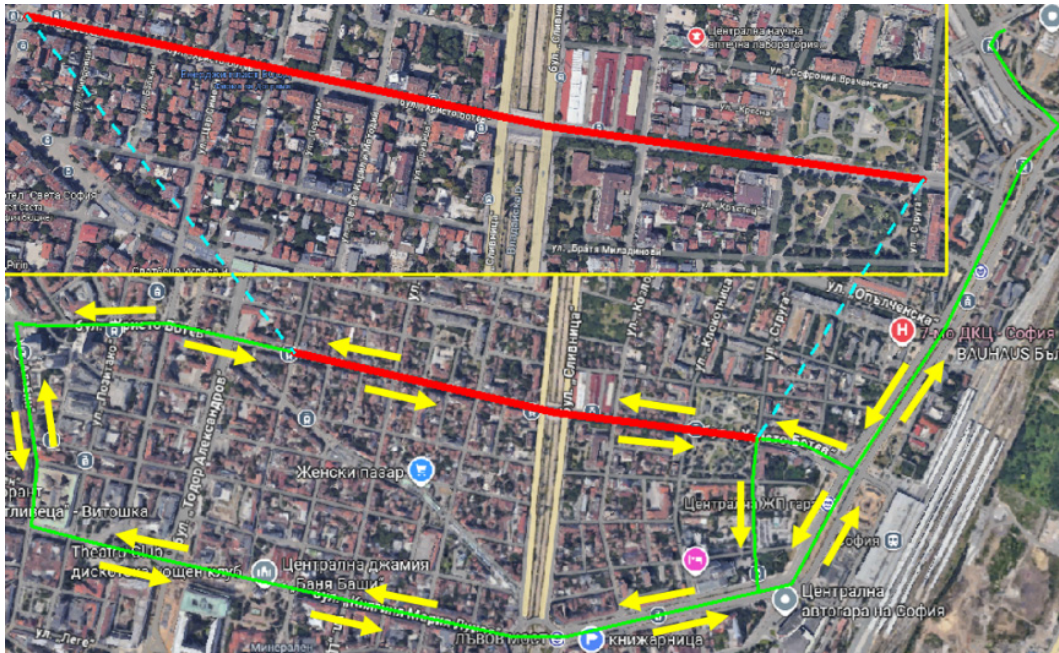
Figure 1: Test route

The measurement was conducted on August 22, 2025, along the route shown in Figure 1. This section provides detailed information regarding the track segment on Hristo Botev Boulevard, extending from Struga Street to Pirotska Street. In this section, the tram track underwent major overhaul in 1998, and currently exhibits severe rail subsidence with a random distribution. The operation of tramcars in this segment is characterized by significant lateral rolling.
